# ConocoPhillips Mississippi River Pipeline Release

August 6 - October 3, 2003

presented by Tim Ganz, former State On-Scene Coordinator,  
Missouri Department of Natural Resources  
Environmental Emergency Response Section

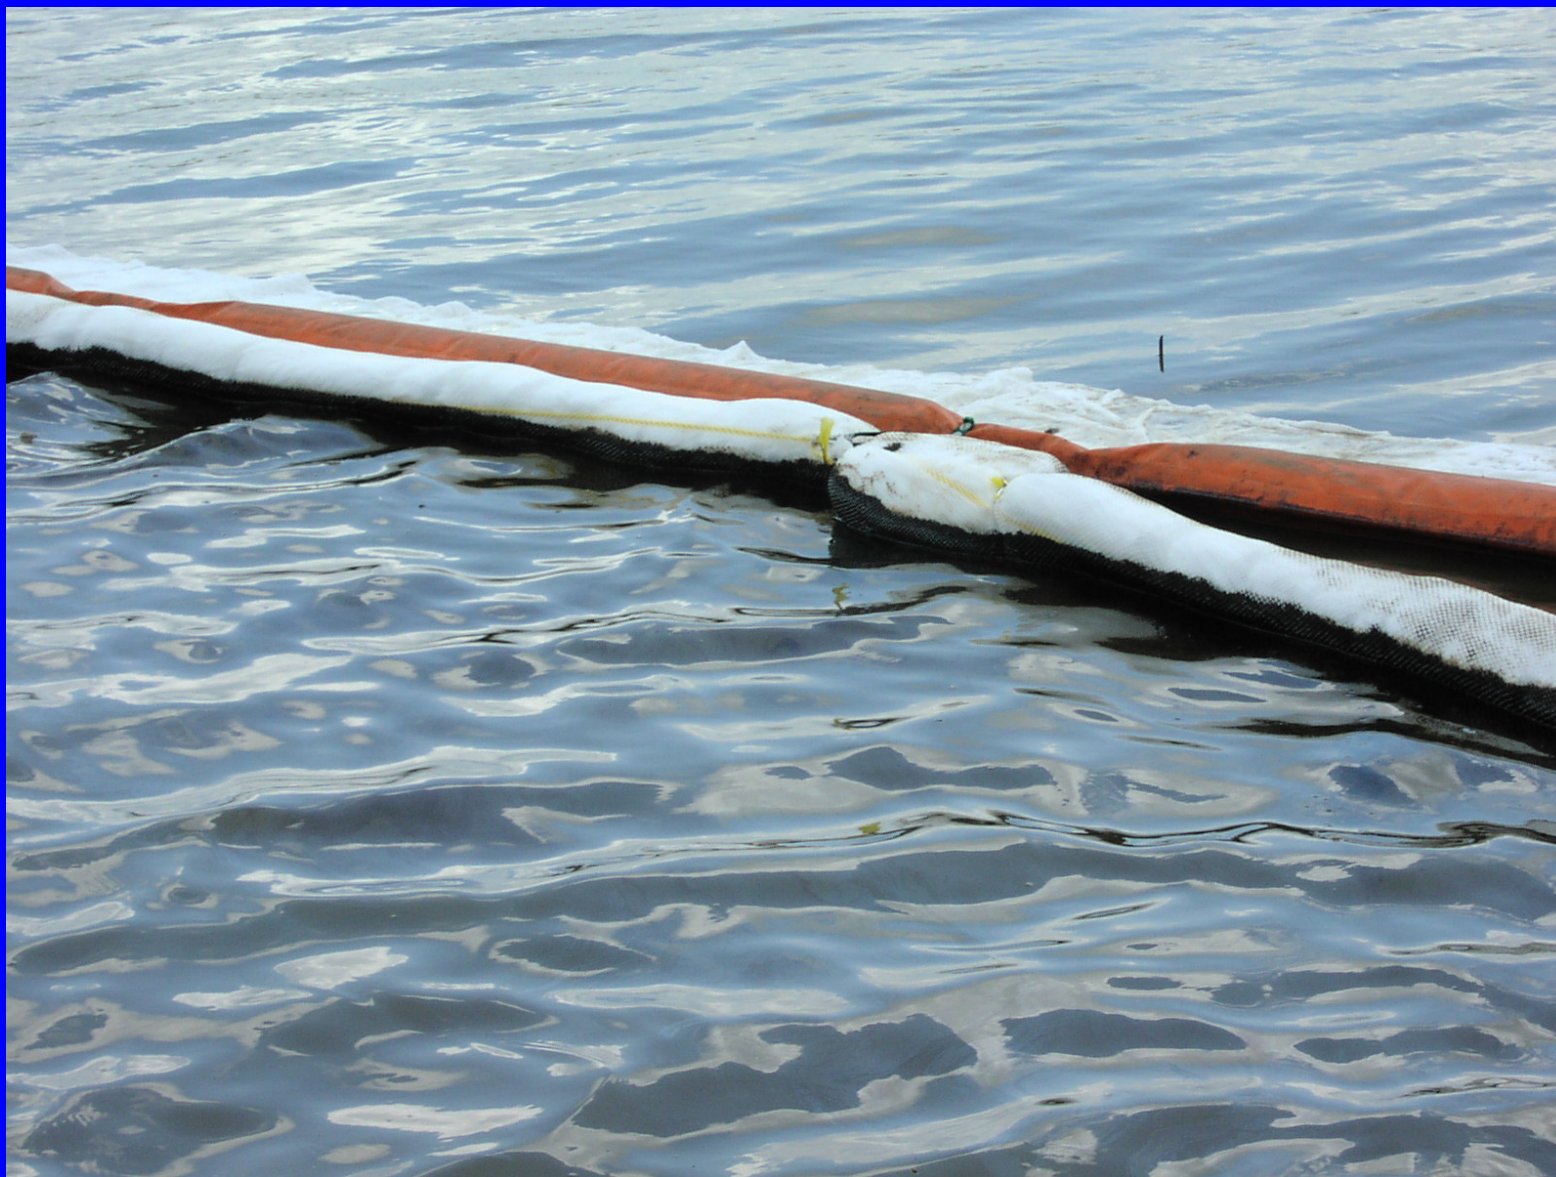
Absorbent boom saturated with crude oil - 08/09/03

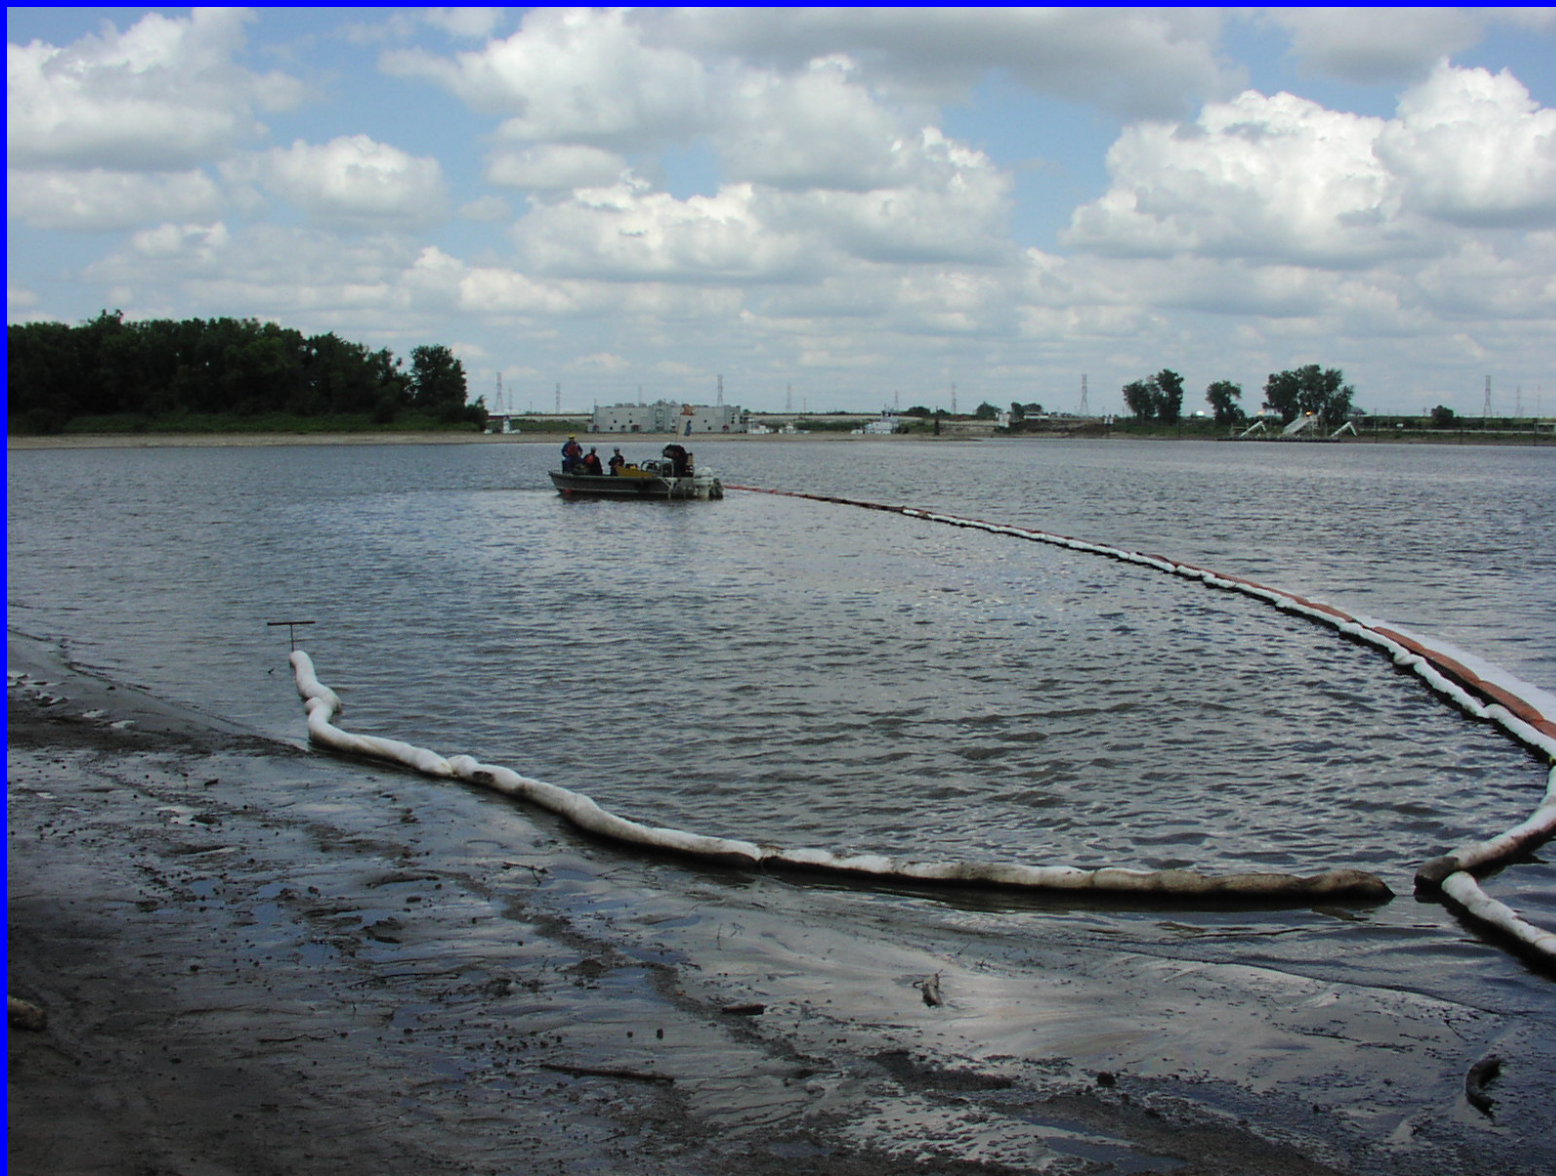
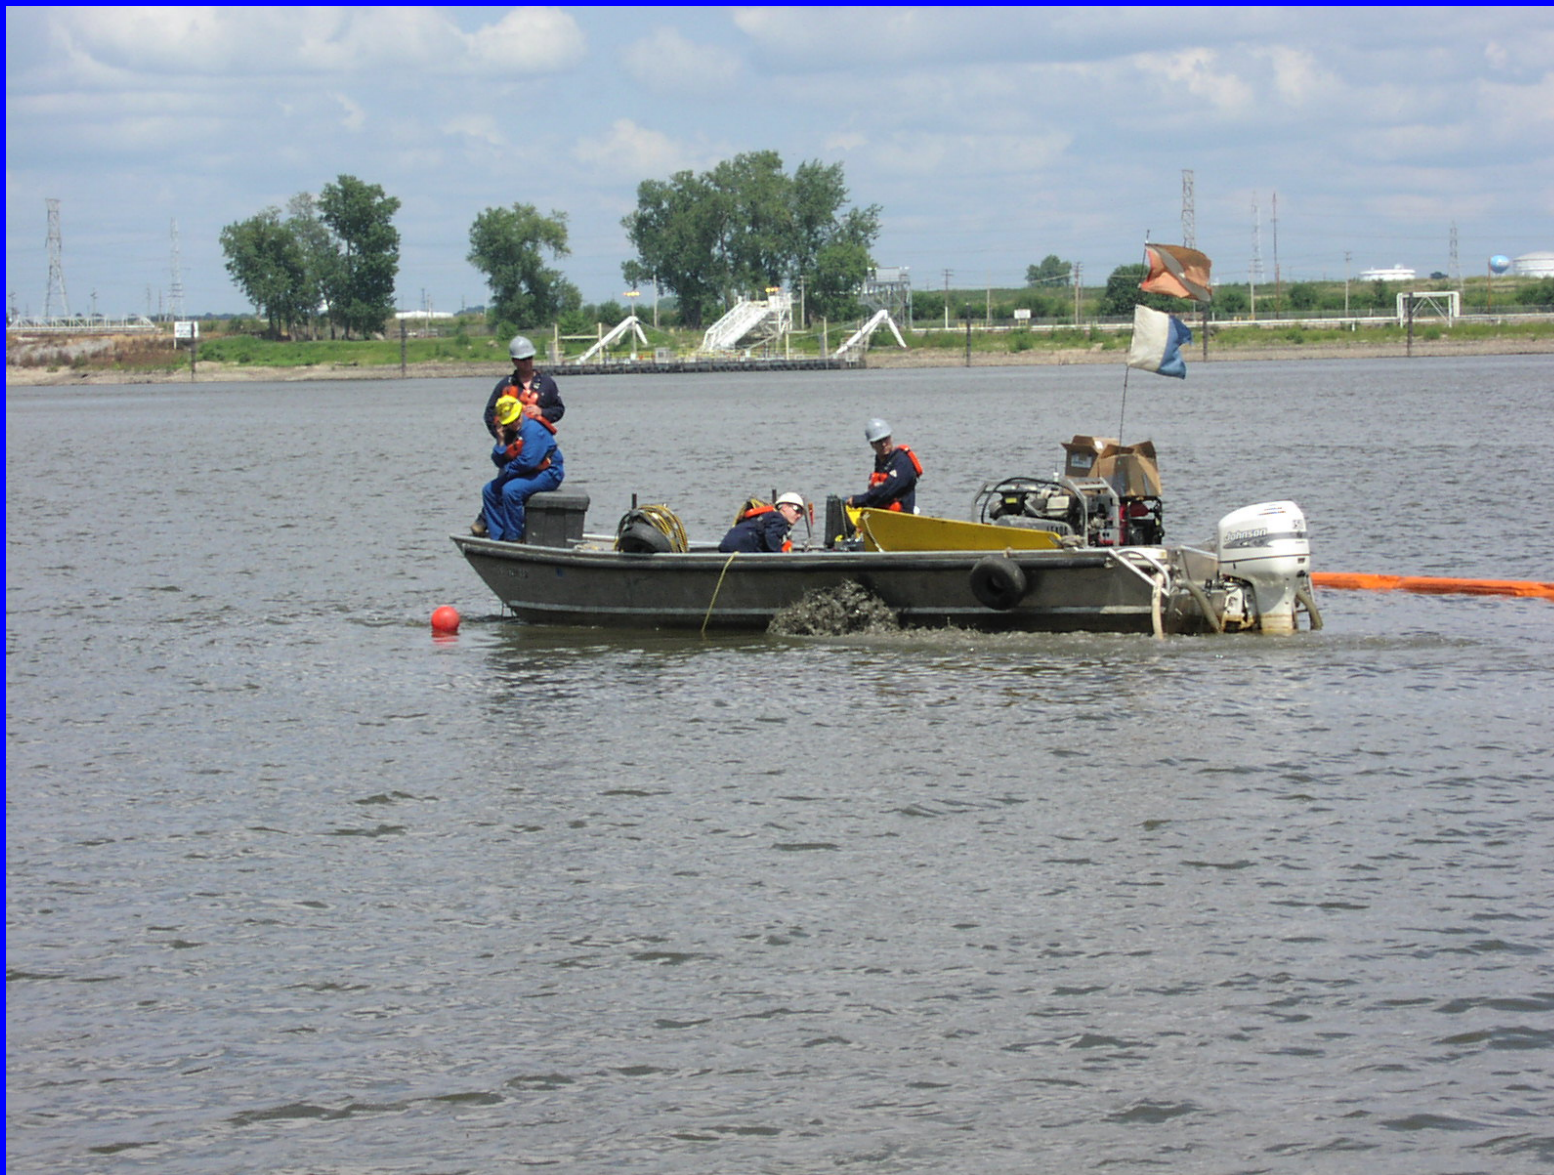
## Dive team disturbing contaminated sediments - 08/09/03

- Dive team hired by ConocoPhillips to find the leak and “patch” the line.
- The dive team found the leak and fastened a “sleeve clamp” to the leak area to stop the leak.
- The dive team disturbed the sediments around the south line causing a release of crude oil.

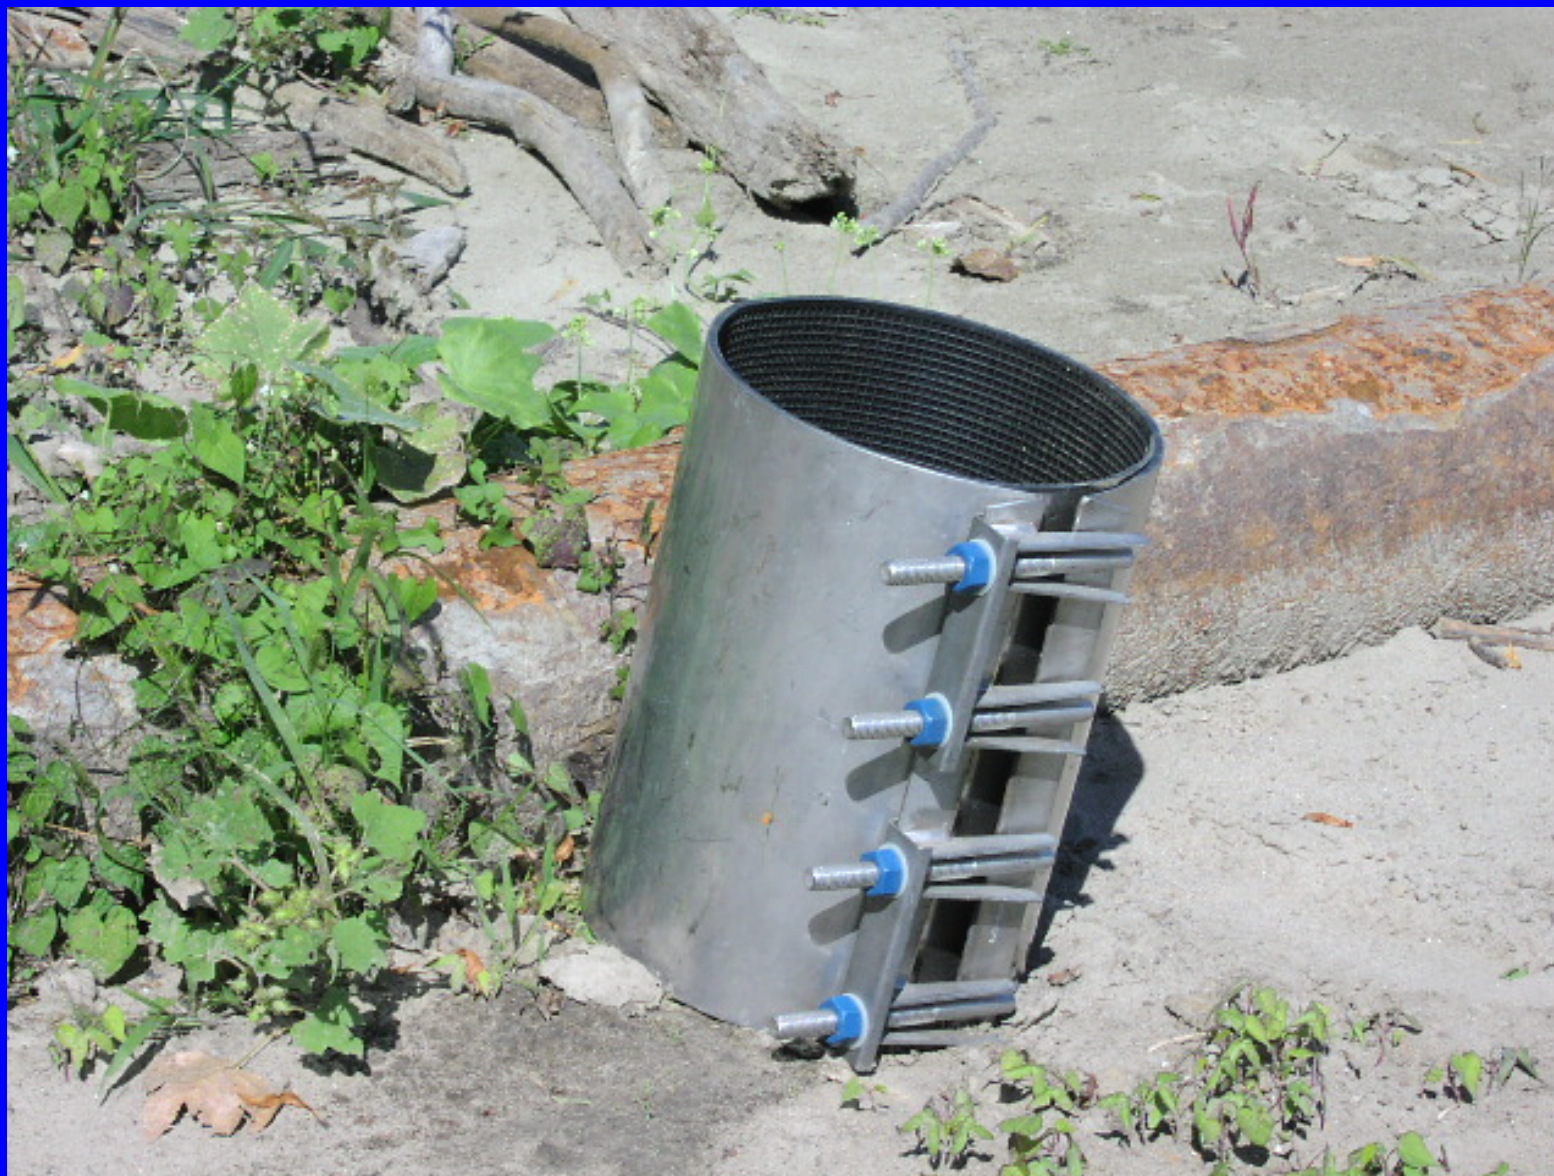
Metal sleeve used to “patch” the leak on the south line

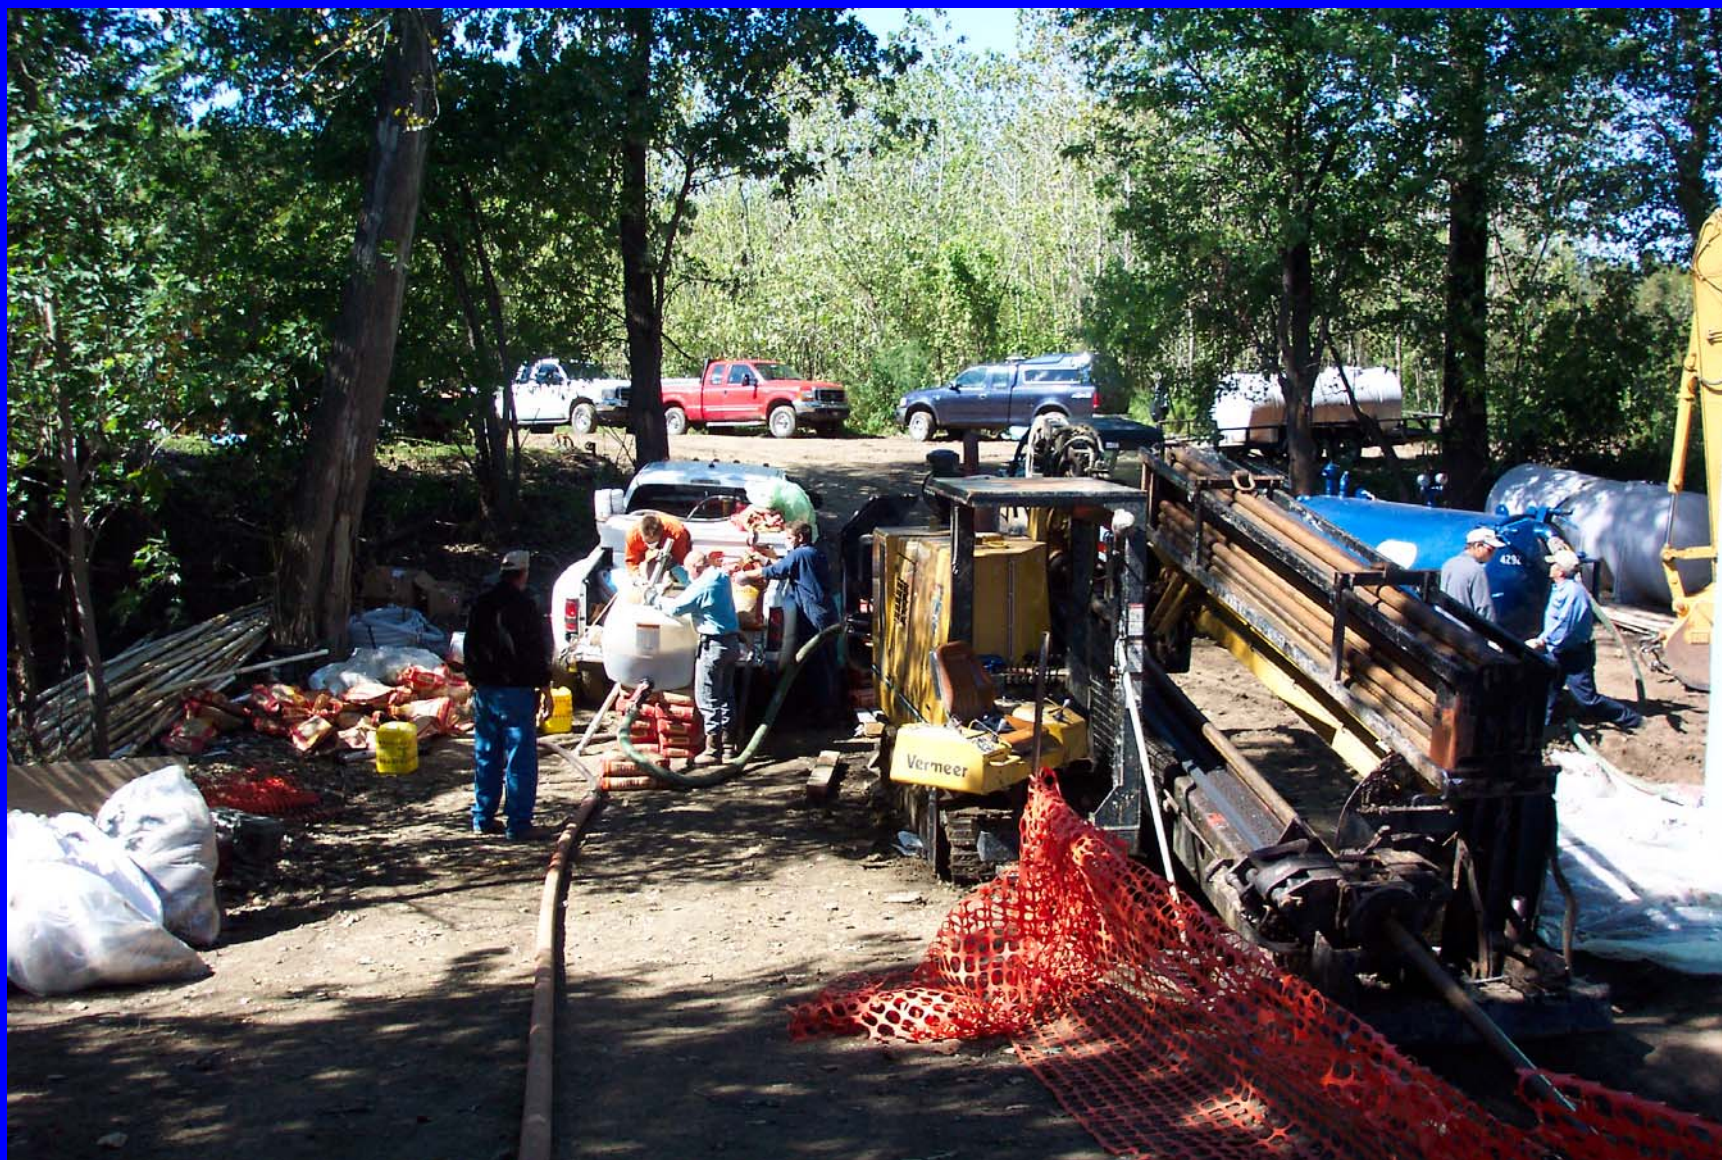
## Horizontal drill rig

- Plan is to remove all remaining material from both lines
- Continue pumping out liquids
- Use a horizontal drill rig to insert a “pig” into the south line to “swab” the line
- Cap the severed end of the north line
- Fill both lines with concrete/drilling mud

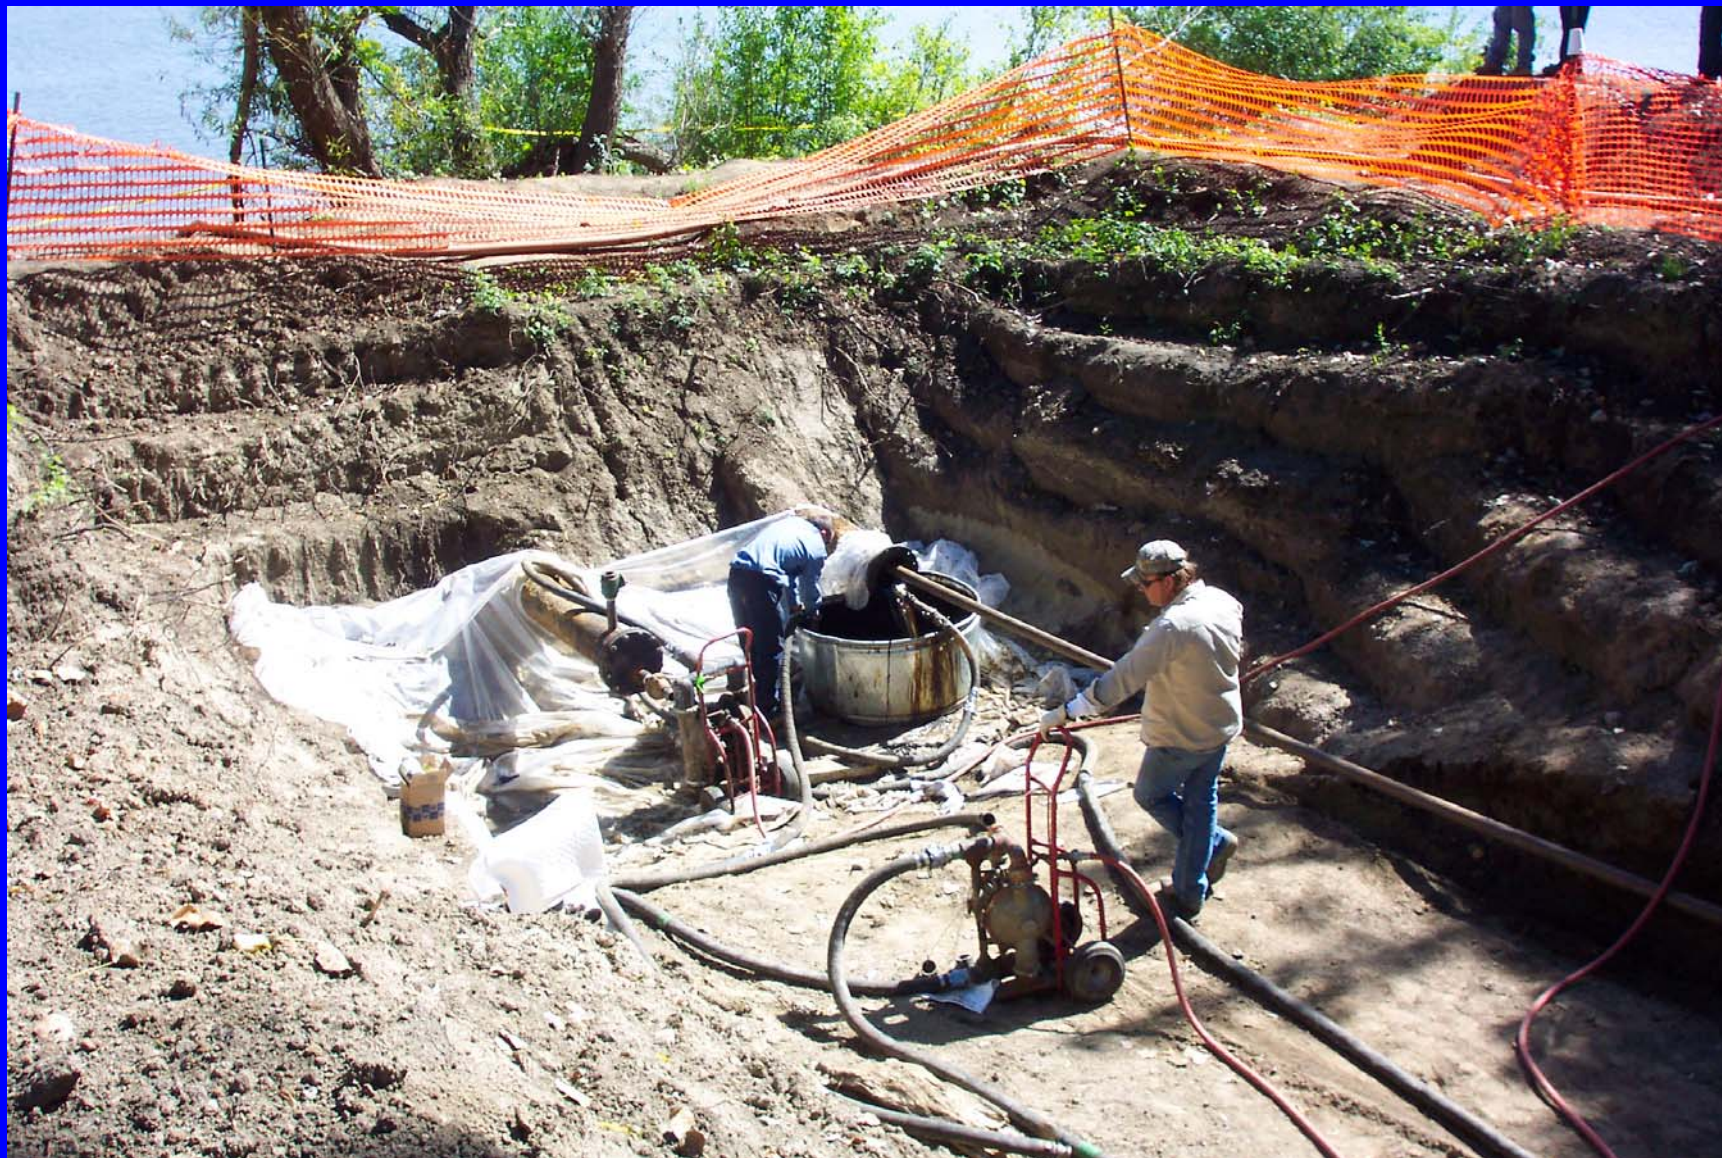
## Insertion of drill stem into south line

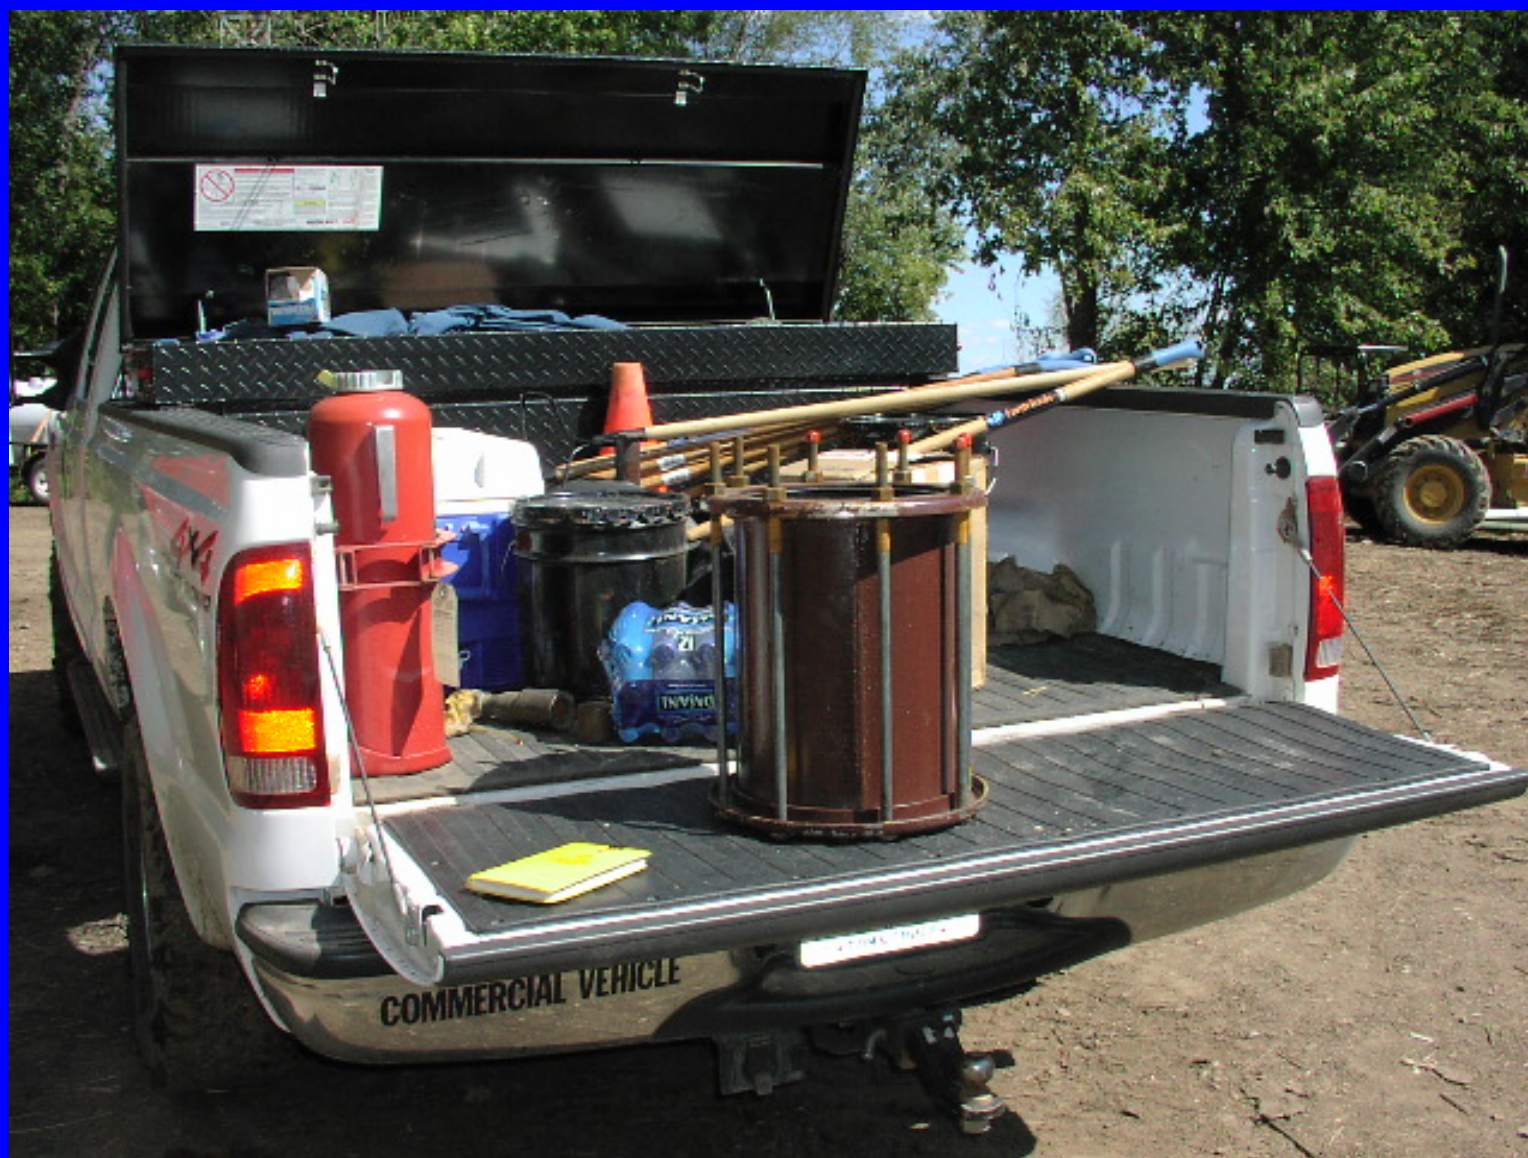
Steel sleeve used to cap the end of the north line

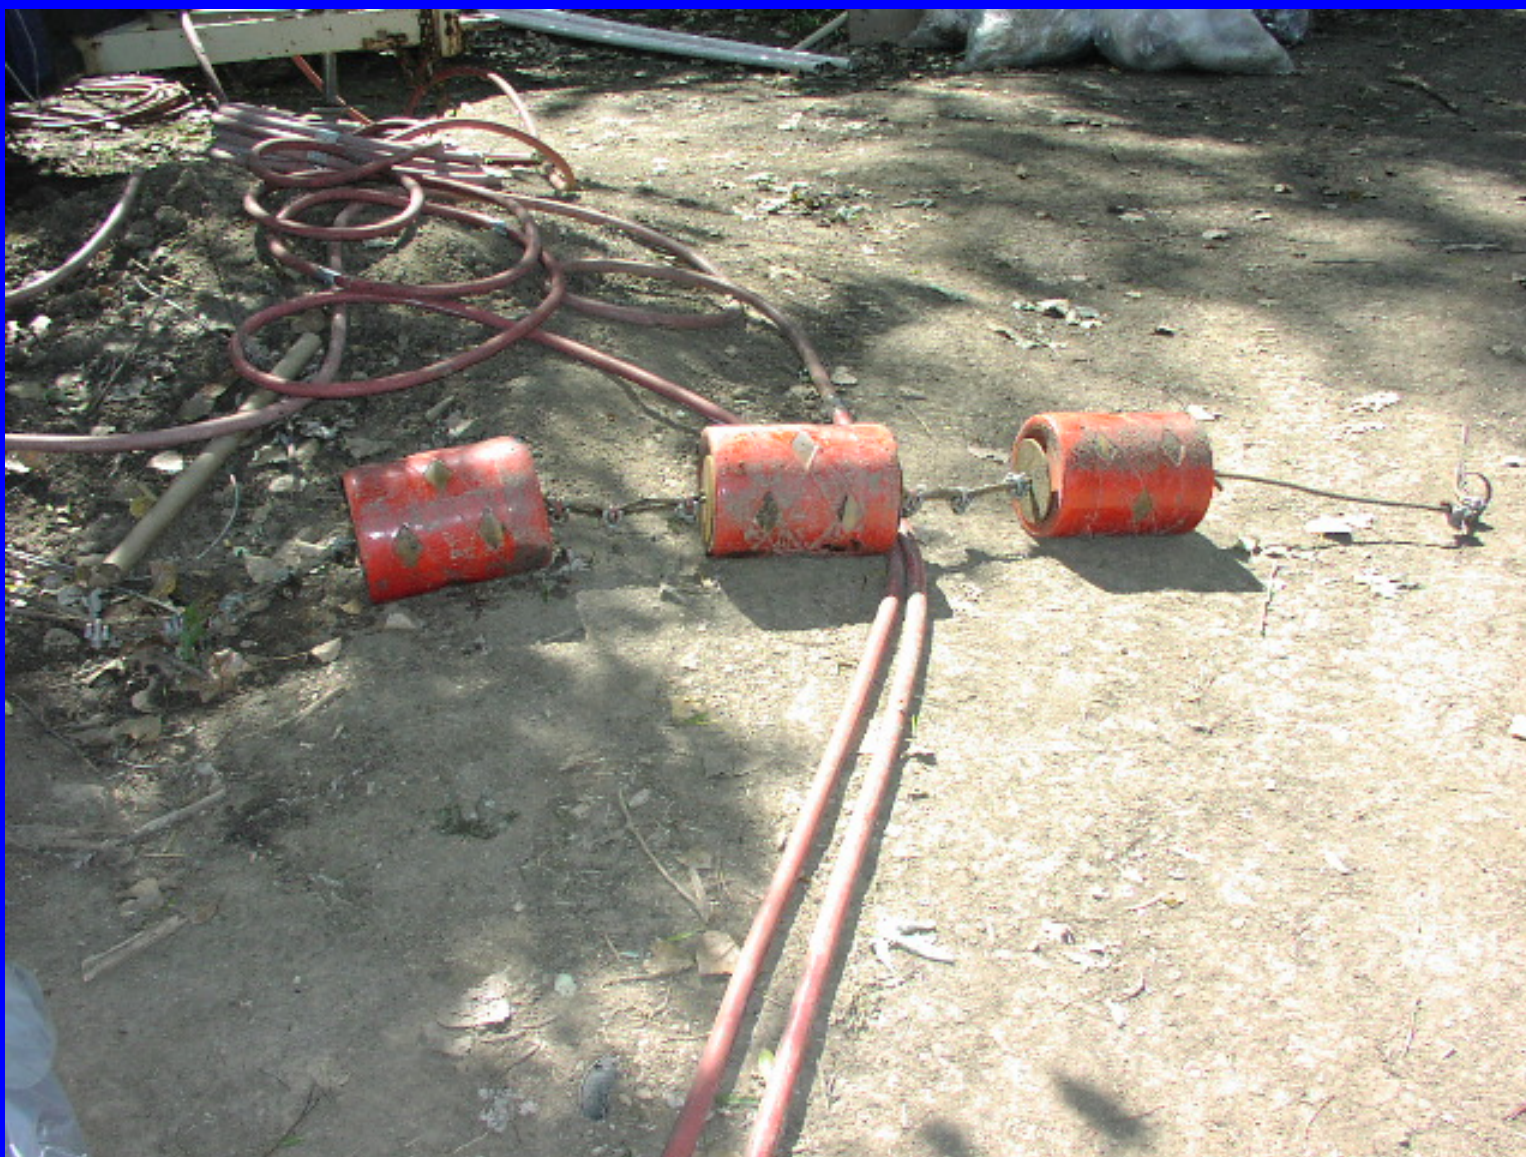
Eight inch diameter pig train

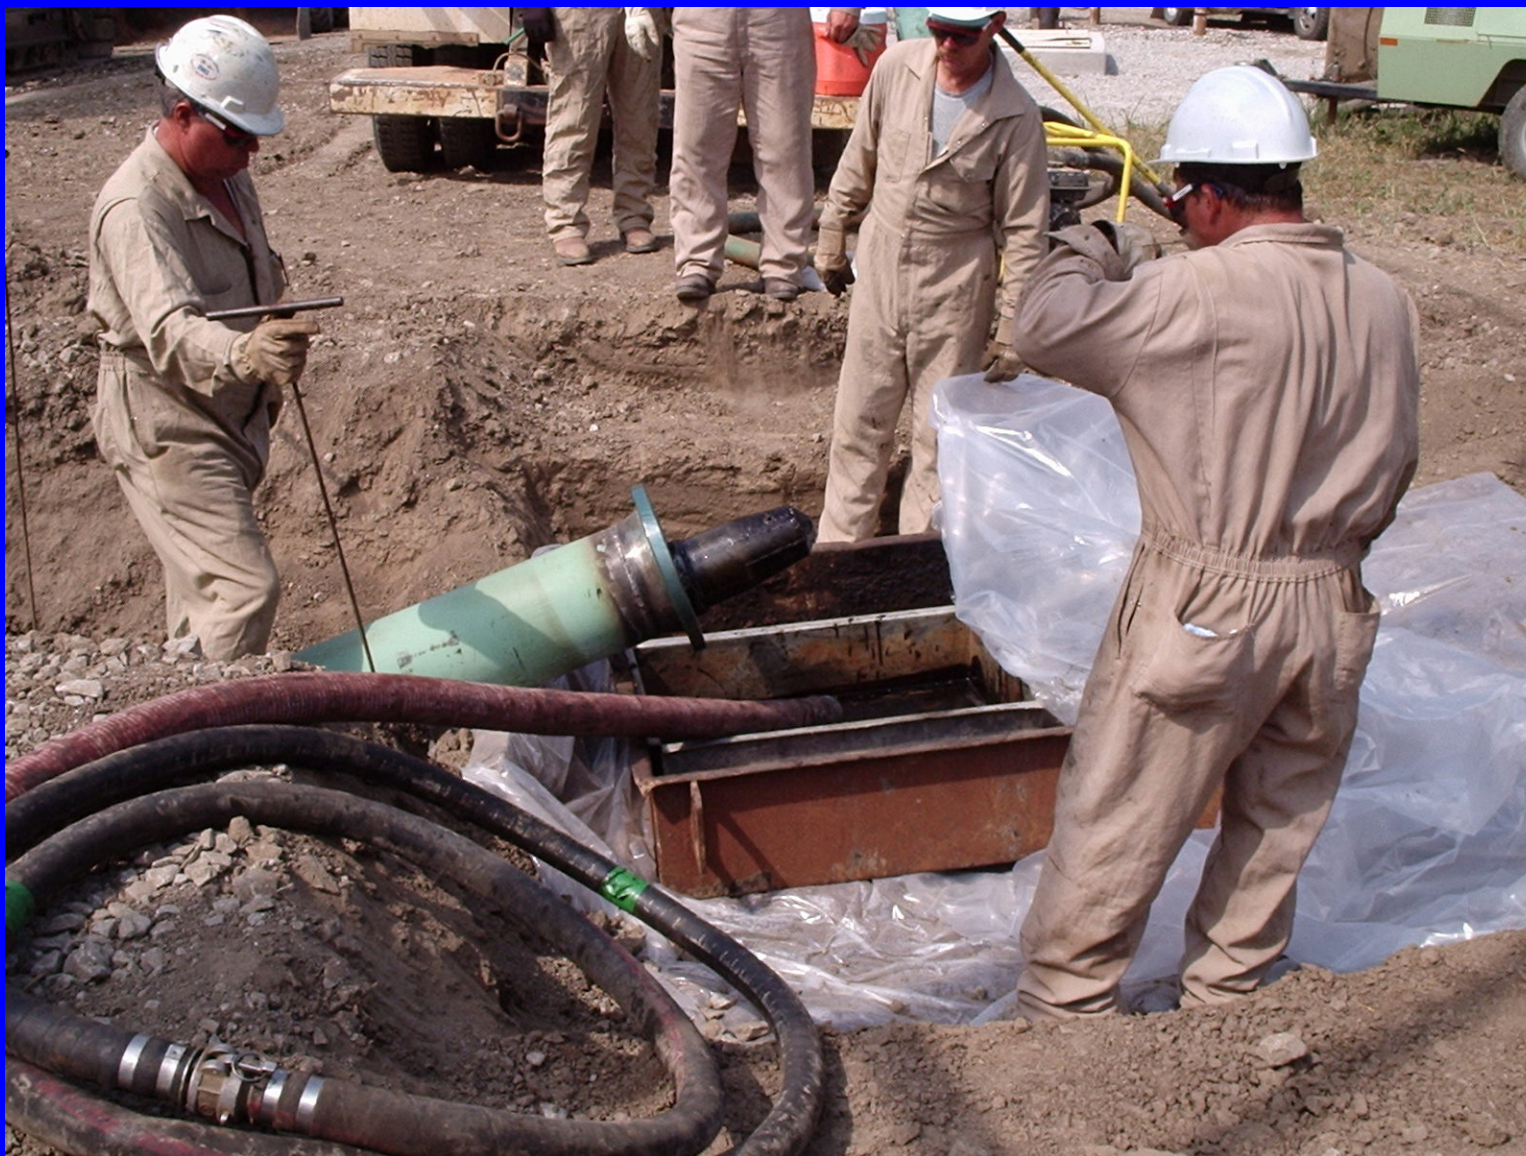
Push-head coming out of south line on Illinois side

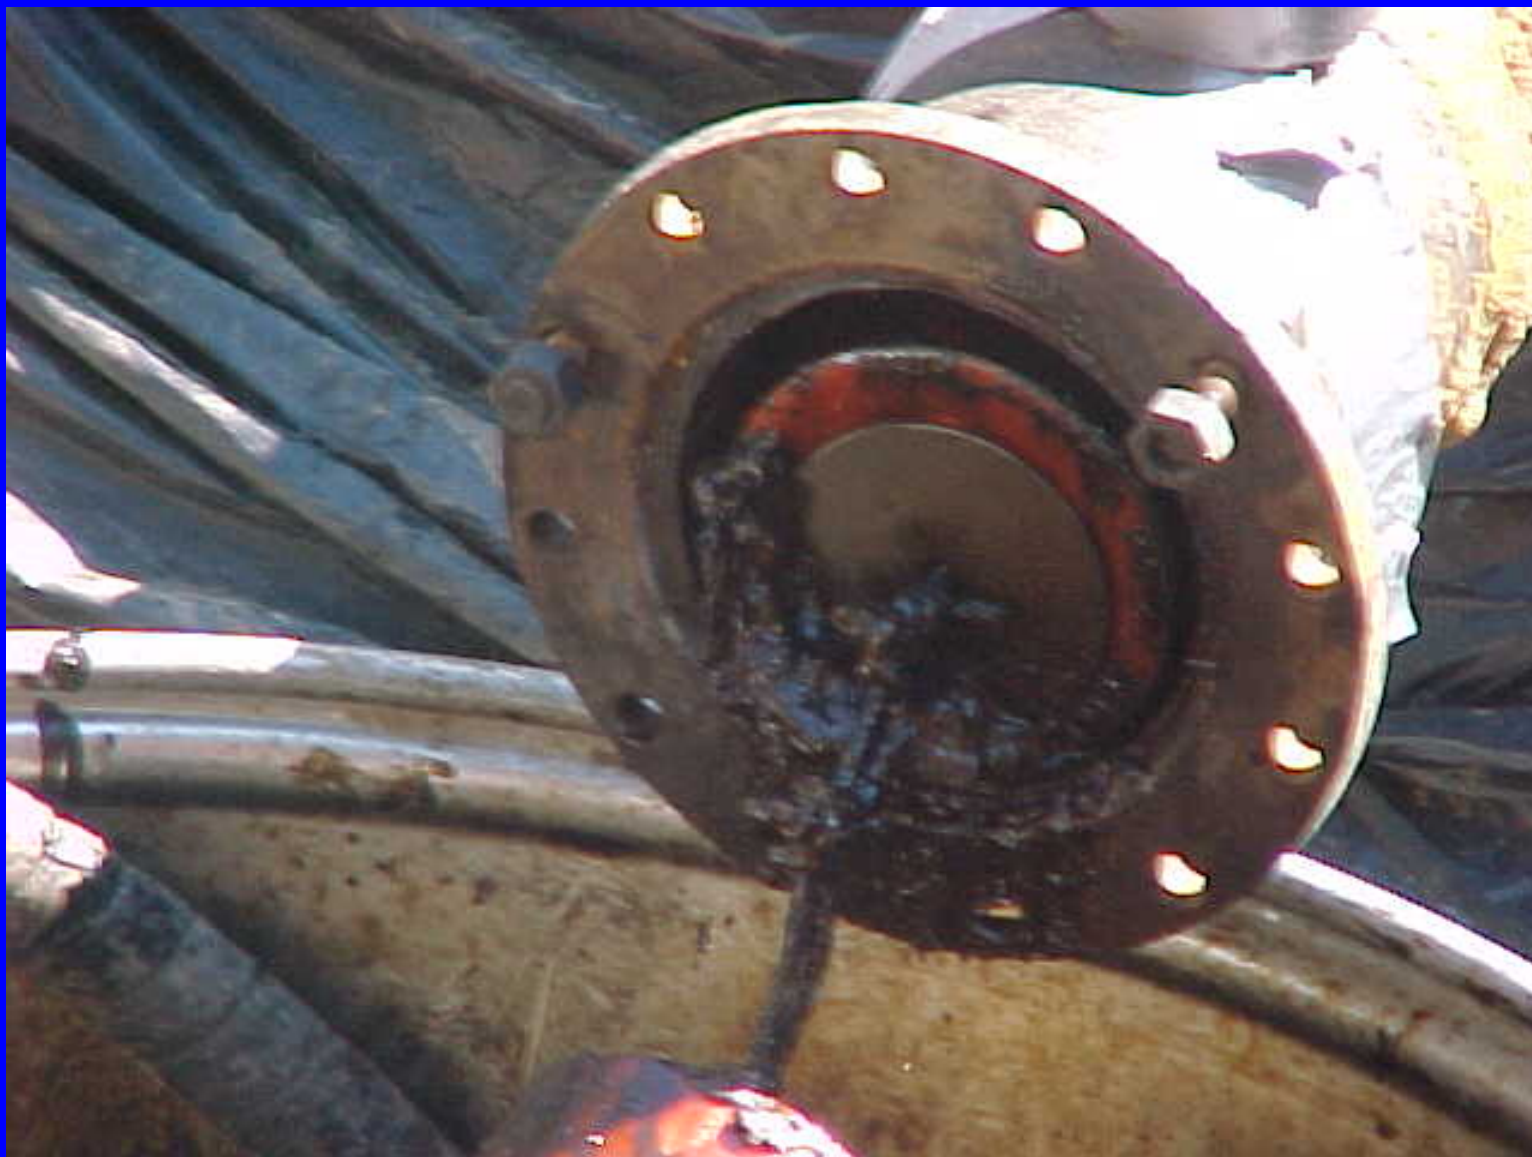
Pig being pulled through the south line, Illinois side -  
09/08/03
